Manhole Inspection Summary

Manhole # S45MM_019MH

Insp Date: **3/25/08 9:39 AM**

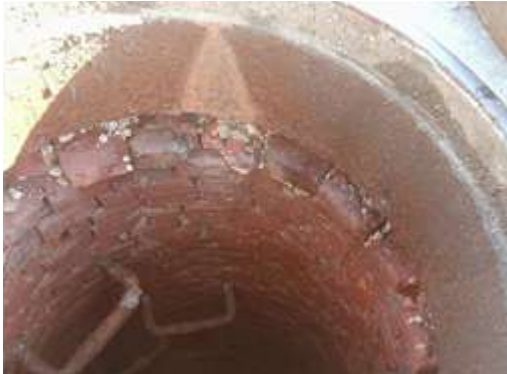
Defect 2

☒ **Leaks**

Frame leaks

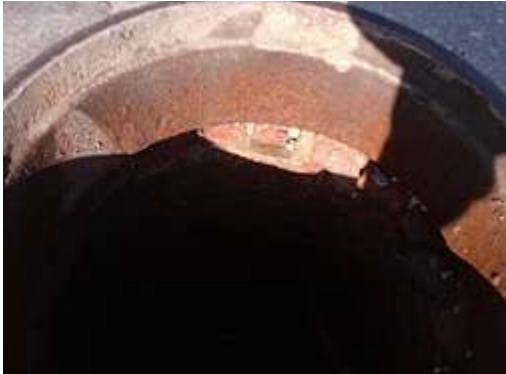
Defect 1

Offset: **0.5** (in.)

Frame offset

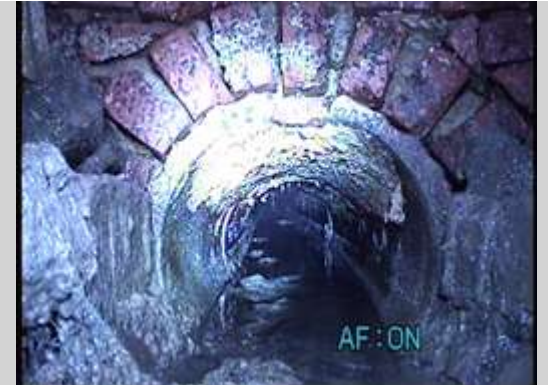
12 O'Clock Outflow

Pipe Height: **12** (in.) Rod and Bar (Angled)
Pipe Material: **Clay** ☐ Pipe Lined
Invert Depth: **12.00** (ft.) Flow Characteristics: **Fast**
Deposits: ☐ None ☐ **Mud** ☐ Sludge ☒ **Debris** ☒ **Grease**
Silt Depth: **3** (in.) Deposits Extent: **Medium**
Infiltration: **None** Pipe Seal Cond: **Sound**

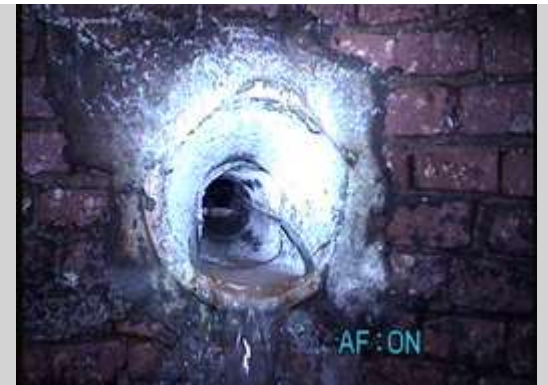
3 O'Clock Inflow

Pipe Height: **8.4** (in.) Rod and Bar (Angled)
Pipe Material: **Clay** ☐ Pipe Lined
Invert Depth: **9.60** (ft.) Flow Characteristics: **Fast**
Deposits: ☒ None ☐ **Mud** ☐ Sludge ☐ **Debris** ☐ Grease
Silt Depth: **8** (in.) Deposits Extent: **Heavy**
Infiltration: **None** Pipe Seal Cond: **Unknown**

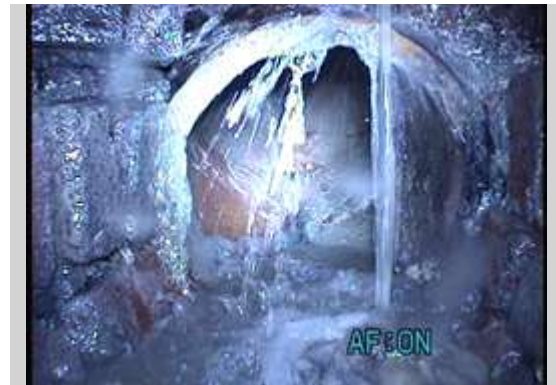
Drop In @ 3 O'Clock

Drop: **Inside** Rod and Bar
Angled: **Yes** Reading: **10.80** (ft.)
Inv Depth: **11.80** (ft.)
Drop Condition: **Clogged**

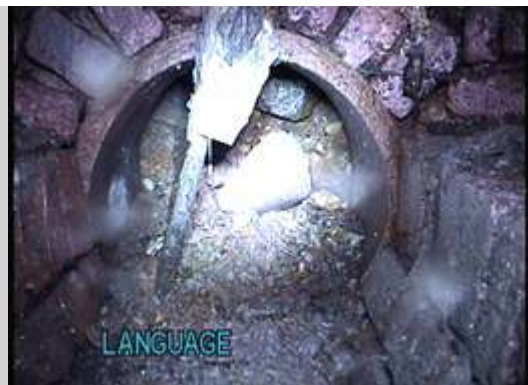
6 O'Clock Inflow

Deposits: ☐ None ☒ **Mud** ☐ Sludge ☒ **Debris** ☐ Grease

Silt Depth: **8** (in.) Deposits Extent: **Heavy**

Connects To: **Stub connection / abandoned**
